**Flood Control Project Maintenance  
Levee Inspections**

**Fall 2018 Levee Maintenance Deficiency Summary Report**

**Flood Control Project Maintenance  
Levee Inspections****LMA District Cover Sheet****Fall 2018 Levee Inspection Results****Reclamation District No. 0501 Ryer Island**

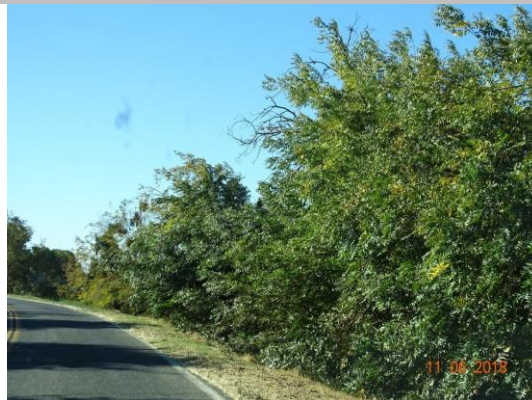
Photo 1 of 1 : FA\_2018\_RD0501\_169\_42\_20181106\_00062.jpg

LM Start	0.06	Rating **	M	Issue No.	42
LM End	0.08	Issue Type +	Ma	Location *	LS
Category	Earthen Levee			GPS Latitude/Longitude	
				Start	End
Item	Trim / Thin Trees			38.253783 °	38.253525 °
				-121.602077 °	-121.602265 °
DWR ID	DWR_RD0501_01_f_2018_42				
Comment Code					
T2 : Thin trees to allow visibility of the ground and room to flood fight.					
Inspector Comment

View looking downstream at relatively thick trees on the land side slope (November 2018).

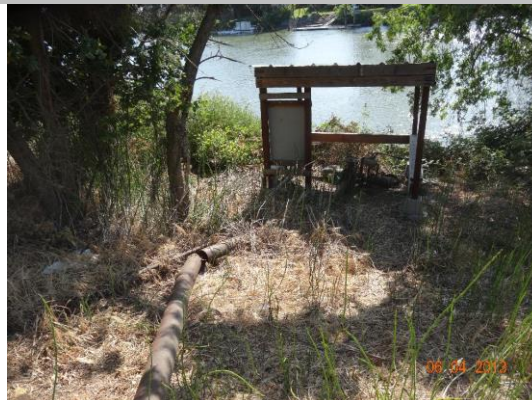
Photo 3 of 3 : UCIP\_FA\_2018\_53350\_58924.jpg

UCIP Comments: 07/24/2018 Same as last inspection. Appears not in use; WS appears not in use due to pipe disconnection, but cannot confirm based on LS connections being intact. PVC pipe sleeved through levee, so downgrading to Non-Urgent. Recommend internal pipe inspection (D. Sanoski - DWR UCIP).8/22/2016 Sacramento County has re-paved road and patch is no longer present. Crossing remains to be Urgent due to the unknown condition of the section of the levee along pipe alignment. Unable to determine if any internal erosion is present along pipe. According to LMA representative, Stacy Boyd, no additional sink holes have developed since 2013. No sink holes have been noticed since PVC pipe was sleeved through existing steel pipe. Permit authorizing work is not available. Need to identify current owner. Owner will need to coordinate with CVFPB to remove or abandon crossing per Title 23 requirements. (DWR UCIP - omagana)6/04/2013 Damage present on levee crown--unable to confirm if damage due to leak in pipe. Signs of repair work on crown, however, no permit found to document recent damage to levee or repair work. New PVC pipe has been sleeved through the existing 6-inch pipe. Unable to determine if crossing is still in use, if not, crossings needs to be removed according to CVFPB Title 23 requirements. (DWR UCIP - omagana)

Overview of WS--pump, abandoned pipe section, and conduit.

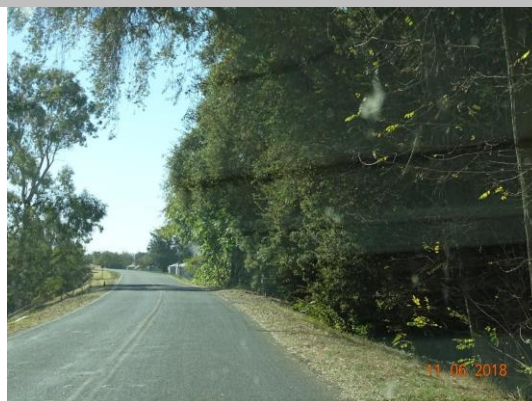
Photo 1 of 1 : FA\_2018\_RD0501\_169\_44\_20181106\_00063.jpg

LM Start	0.22	Rating **	M	Issue No.	44
LM End	0.28	Issue Type +	En	Location *	LS
Category	Earthen Levee			GPS Latitude/Longitude	
				Start	End
Item	Vegetation			38.251598°	38.250730°
				-121.603068°	-121.603190°
DWR ID	DWR_RD0501_01_f_2018_44				
Comment Code					
V6 : Landscaping					
Inspector Comment					
Landscaping trees are obstructing view down the land side slope

View looking downstream at landscaping trees on the land side slope (November 2018).

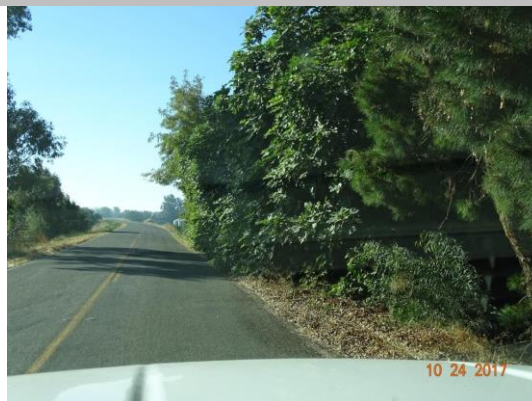
Photo 1 of 1 : FA\_2018\_RD0501\_169\_27\_20180925\_00002.jpg

LM Start	0.28	Rating **	M	Issue No.	27
LM End	0.28	Issue Type +	En	Location *	LS
Category	Earthen Levee			GPS Latitude/Longitude	
				Start	End
Item	Vegetation			38.250809 °	38.250809 °
				-121.603119 °	-121.603119 °
DWR ID	DWR_RD0501_01_f_2017_27				
Comment Code					
V6 : Landscaping					
Inspector Comment					
Trim fig trees to allow inspection and access to landside slope and toe.

Trim fig trees to allow inspection and access to landside slope and toe.

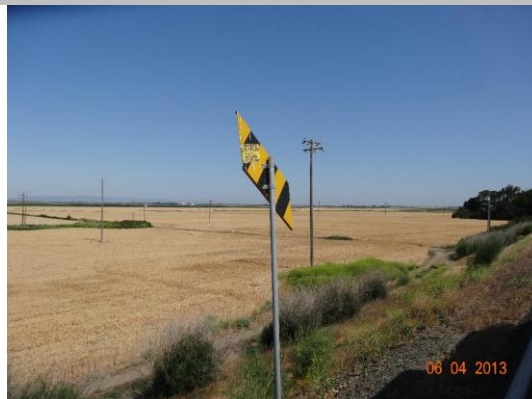
Photo 2 of 3 : UCIP\_FA\_2018\_41409\_58930.jpg

Comment Code						
Inspector Comment						
FS_ID:41409 DS_ID:21032 EP_NO: N/A Repair Type: Non-Urgent Crossing Status: Found UCIP Comments: Need to contact owner and ask for emergency contact information and permit number. 8/21/13 Contacted Gas Control Division under the emergency contact No. 1-877-723-3344. Message has been forward to Brian Habersack at 916-859-4700, email: bhabersack@gasbiz.com. FIELD_STRUCT_DESC: 6-inch steel natural gas pipeline under the levee, 60 feet below the crown. Gas line marker on each shoulder. (Plans to install a 6-inch steel natural gas pipeline across and bored under the channel and each levee authorized under Permit No. 17033, 1999 - Delta Gas Gathering, Inc., and A. A. Production Services, Inc.). [Additional Reference(s): DWR Levee Log, 2005]. FS Date: 6/4/2013

Overview of landside at crossing. Marker on shoulder.

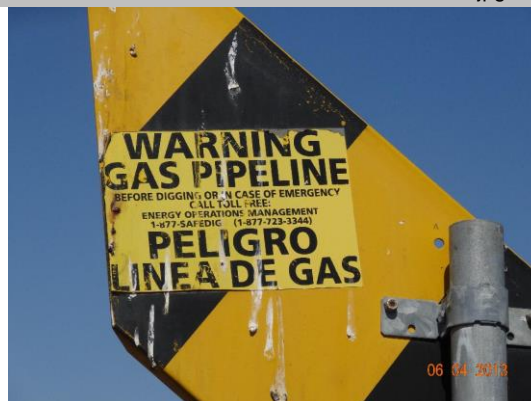
Photo 3 of 3 : UCIP\_FA\_2018\_41409\_58932.jpg

Comment Code						
Inspector Comment						
FS_ID:41409 DS_ID:21032 EP_NO: N/A Repair Type: Non-Urgent Crossing Status: Found UCIP Comments: Need to contact owner and ask for emergency contact information and permit number. 8/21/13 Contacted Gas Control Division under the emergency contact No. 1-877-723-3344. Message has been forward to Brian Habersack at 916-859-4700, email: bhabersack@gasbiz.com. FIELD_STRUCT_DESC: 6-inch steel natural gas pipeline under the levee, 60 feet below the crown. Gas line marker on each shoulder. (Plans to install a 6-inch steel natural gas pipeline across and bored under the channel and each levee authorized under Permit No. 17033, 1999 - Delta Gas Gathering, Inc., and A. A. Production Services, Inc.). [Additional Reference(s): DWR Levee Log, 2005]. FS Date: 6/4/2013

Gas line contact information on the sign.

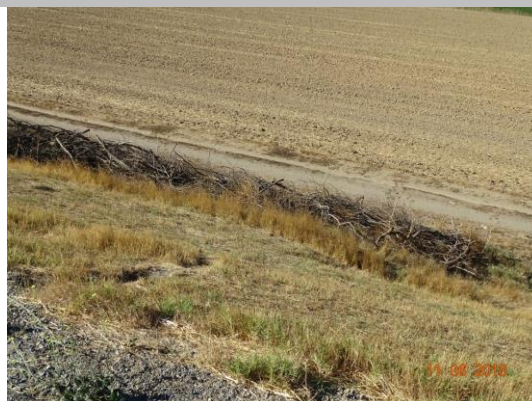
Photo 1 of 1 : FA\_2018\_RD0501\_169\_45\_20181106\_00064.jpg

LM Start	0.47	Rating **	M	Issue No.	45
LM End	0.47	Issue Type +	En	Location *	LS
Category	Earthen Levee			GPS Latitude/Longitude	
				Start	End
Item	Encroachments			38.247957 °	38.247957 °
				-121.602965 °	-121.602965 °
DWR ID	DWR_RD0501_01_f_2018_45				
Comment Code					
PR : Prunings					
Inspector Comment					
Remove prunings from land side toe

View of prunings on the land side toe (November 2018).

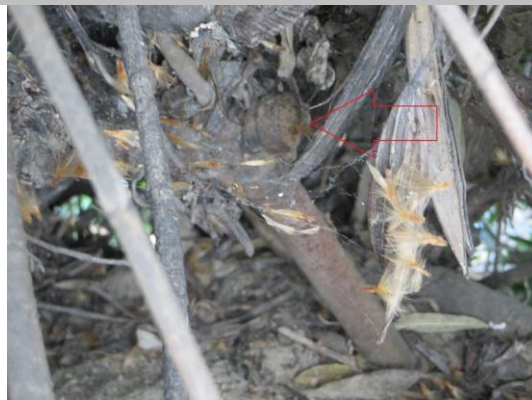
Photo 2 of 3 : UCIP\_FA\_2018\_44643\_73841.jpg

Comment Code					
Inspector Comment					
FS_ID:44643 DS_ID:21089 EP_NO: 2683 Repair Type: Non-Urgent Crossing Status: Indicator Found UCIP Comments: Appears abandoned and if so should be done so properly. FIELD_STRUCT_DESC: *ABANDONED* 2-inch steel water pipe and a 1-inch steel electrical conduit through the levee, both 3 feet below the crown. Portion of pipe visible under the oleanders on the landside (LS) shoulder, may be part of this crossing. No evidence remains on the waterside (WS) slope. (Plans for installation of an electrical conduit and a water pipe through the levee authorized under Permit No. 2683, 1957 - John Gosner). FS Date: 4/21/2015

Pipes visible under oleander on LS shoulder.

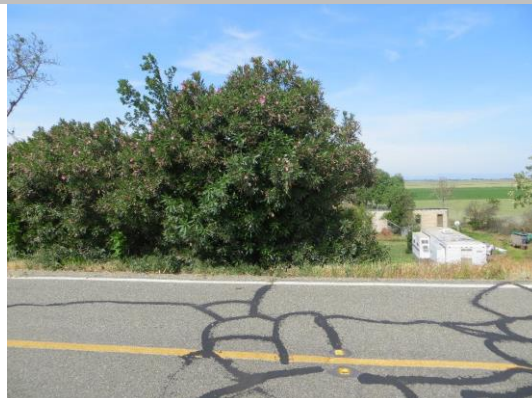
Photo 3 of 3 : UCIP\_FA\_2018\_44643\_73840.jpg

Comment Code						
Inspector Comment						
FS_ID:44643 DS_ID:21089 EP_NO: 2683 Repair Type: Non-Urgent Crossing Status: Indicator Found UCIP Comments: Appears abandoned and if so should be done so properly. FIELD_STRUCT_DESC: *ABANDONED* 2-inch steel water pipe and a 1-inch steel electrical conduit through the levee, both 3 feet below the crown. Portion of pipe visible under the oleanders on the landside (LS) shoulder, may be part of this crossing. No evidence remains on the waterside (WS) slope. (Plans for installation of an electrical conduit and a water pipe through the levee authorized under Permit No. 2683, 1957 - John Gosner). FS Date: 4/21/2015

Pipes visible under oleander on LS shoulder.

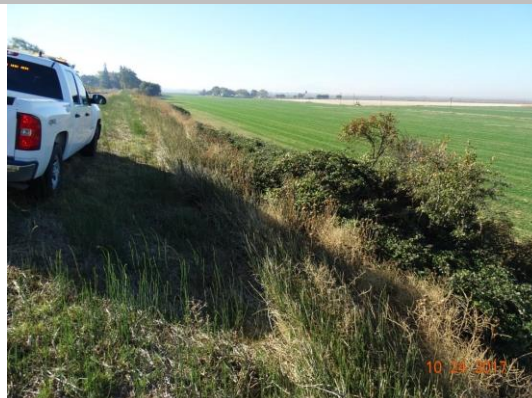
Photo 1 of 1 : FA\_2018\_RD0501\_169\_29\_20180925\_00004.jpg

LM Start	0.76	Rating **	M	Issue No.	29
LM End	1.01	Issue Type +	Ma	Location *	LS
Category	Earthen Levee			GPS Latitude/Longitude	
				Start	End
Item	Vegetation			38.243815 °	38.240257 °
				-121.603077 °	-121.603873 °
DWR ID	DWR_RD0501_01_f_2018_29				
Comment Code					
V2 : Remove the wild growth other than native grasses from the levee slopes.					
Inspector Comment					
Landside slope is covered in blackberry vines. Should be removed to allow inspection and access.

Landside slope is covered in blackberry vines. Should be removed to allow inspection and access.

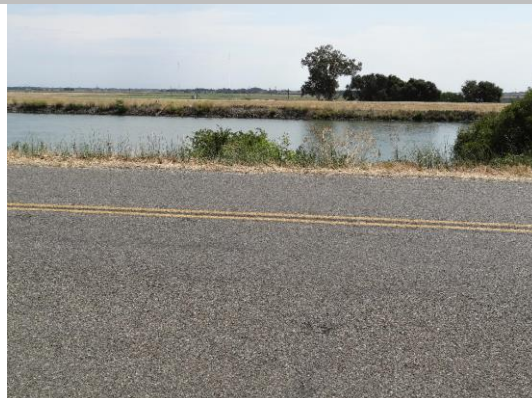
Photo 2 of 3 : UCIP\_FA\_2018\_50020\_75647.jpg

Comment Code						
Inspector Comment						
FS_ID:50020 DS_ID:21034 EP_NO: N/A Repair Type: Non-Urgent Crossing Status: Found UCIP Comments: 8/22/2016 Crossing has been downgraded from Urgent to Non-Urgent -- no evidence of damage to levee is present. Dense vegetation limits the inspector's visibility to identify signs of pipe failure (leaks) through the slope. Recommend removing vegetation along pipe alignment to conduct proper inspection of structure and appurtenances. Also will need to coordinate with owner to determine if permit was obtained for the modifications made to crossing (PVC pipe sleeved through existing pipe). (DWR UCIP - omagana)4/21/2015 Unauthorized PVC pipe. Annular space not grouted. 14-inch pipe open on both ends. (DWR UCIP - omagana) FIELD_STRUCT_DESC: 14-inch steel irrigation siphon pipe through the levee, 3.2 feet below the crown. 10-inch polyvinyl chloride (PVC) pipe sleeved through the 14-inch pipe. Siphon breaker on the landside (LS) shoulder. [Additional Reference(s): DWR Levee Log, 2005. USACE Sacramento O&M Manual 105, April 1959, (HLM 1.0)]. FS Date: 8/22/2016

View of levee crown looking at waterside.

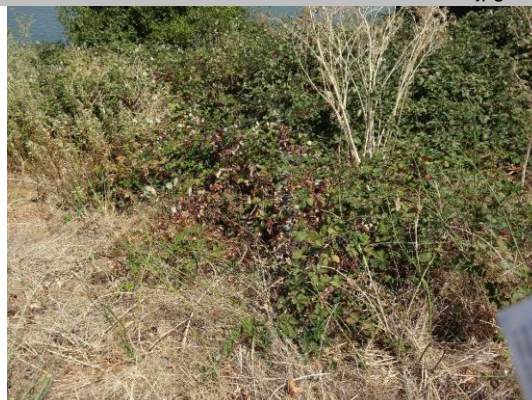
Photo 3 of 3 : UCIP\_FA\_2018\_50020\_75645.jpg

Dense vegetation covers WS--pipe slightly visible through vegetation.

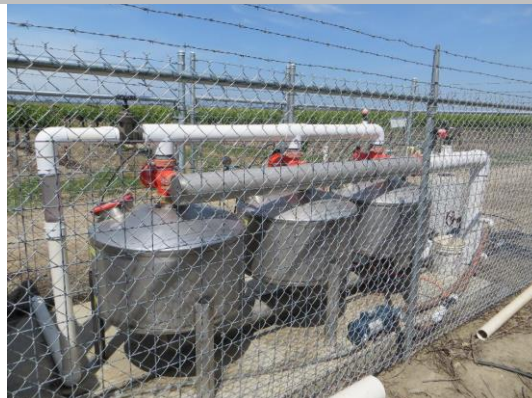
Photo 1 of 3 : UCIP\_FA\_2018\_47516\_73857.jpg

Comment Code						
Inspector Comment						
FS_ID:47516 DS_ID:21086 EP_NO: 13233 Repair Type: Non-Urgent Crossing Status: Found UCIP Comments: Annular space between pipes not grouted. FPIIB Inspector Herman Phillips will contact owner regarding lack of permit for sand filters. Steel plate partially covers openings between pipes. FIELD_STRUCT_DESC: 14-inch coated steel irrigation discharge pipe through the levee, 2.5 feet below the crown. 8-inch steel pipe sleeved through the 14-inch pipe. Cutoff wall around the pipe at the center of the levee. Pump and check valve in a pump house on the waterside (WS) slope. Service pole on the landside (LS) slope. A 1.5-inch and a 2.5-inch electrical conduits at the same location. Siphon breaker on each shoulder. (Plans to replace a 12-inch irrigation pipe through the levee authorized under Permit No. 11813, 1976 - Harry H. Rasmussen. Plans to replace irrigation pipe with a 14-inch pipe through the levee authorized under Permit No. 13233, 1981 - Harry H. Rasmussen. Plans to install an 8-inch steel pipe through an existing 14-inch pipe through the levee authorized under Permit No. 11813-1, 2013 - Matt Davis). FS Date: 4/21/2015

Sand filter plant on LS toe.

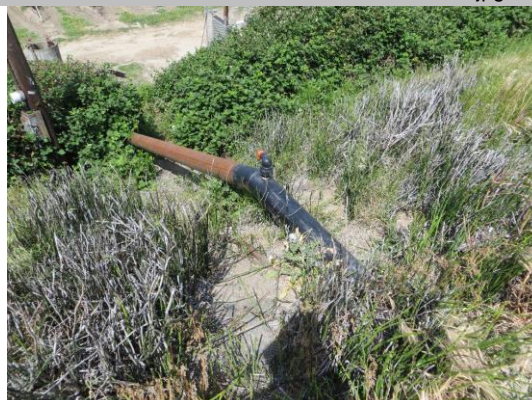
Photo 2 of 3 : UCIP\_FA\_2018\_47516\_73856.jpg

8-inch steel pipe with vent/siphon breaker on LS shoulder. Pipe sleeved through 14-inch steel pipe. Electrical conduit visible next to pipe.

Comment Code						
Inspector Comment						
FS_ID:47516 DS_ID:21086 EP_NO: 13233 Repair Type: Non-Urgent Crossing Status: Found UCIP Comments: Annular space between pipes not grouted. FPIIB Inspector Herman Phillips will contact owner regarding lack of permit for sand filters. Steel plate partially covers openings between pipes. FIELD_STRUCT_DESC: 14-inch coated steel irrigation discharge pipe through the levee, 2.5 feet below the crown. 8-inch steel pipe sleeved through the 14-inch pipe. Cutoff wall around the pipe at the center of the levee. Pump and check valve in a pump house on the waterside (WS) slope. Service pole on the landside (LS) slope. A 1.5-inch and a 2.5-inch electrical conduits at the same location. Siphon breaker on each shoulder. (Plans to replace a 12-inch irrigation pipe through the levee authorized under Permit No. 11813, 1976 - Harry H. Rasmussen. Plans to replace irrigation pipe with a 14-inch pipe through the levee authorized under Permit No. 13233, 1981 - Harry H. Rasmussen. Plans to install an 8-inch steel pipe through an existing 14-inch pipe through the levee authorized under Permit No. 11813-1, 2013 - Matt Davis). FS Date: 4/21/2015

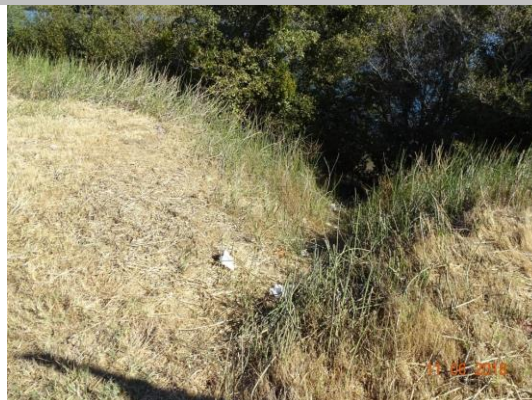
Photo 1 of 2 : FA\_2018\_RD0501\_169\_47\_20181106\_00065.jpg

LM Start	2.07	Rating **	U	Issue No.	47
LM End	2.07	Issue Type +	Ma	Location *	WS
Category	Earthen Levee			GPS Latitude/Longitude	
				Start	End
Item	Slope Stability			38.225070 °	38.225070 °
				-121.603827 °	-121.603827 °
DWR ID	DWR_RD0501_01_f_2018_47				
Comment Code					
S2 : Repair the levee slope damaged by foot traffic and prevent access where possible.					
Inspector Comment					
Deep gouges in the water side slope due to heavy foot traffic. LMA put sign up to deter foot traffic and it has been effective.

View of foot path that is more than 1 foot deep into the water side slope (November 2018).

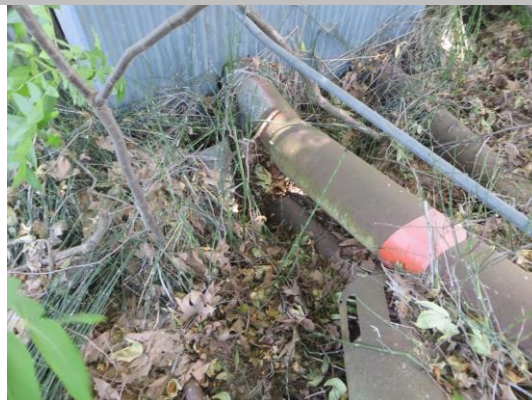
Photo 3 of 3 : UCIP\_FA\_2018\_44683\_73880.jpg

LM Start	2.34	Rating **	M	Issue No.	986 (cont)	
LM End	2.34	Issue Type +	En	Location *		
Category	Supplemental			GPS Latitude/Longitude		
				Start	End	
Item	DWR UCIP Field Study			38.221277°	38.221277°	
				-121.603505°	-121.603505°	
DWR ID	21021					
Comment Code						
Inspector Comment						
FS_ID:44683 DS_ID:21021 EP_NO: N/A Repair Type: Non-Urgent Crossing Status: Found UCIP Comments: Appears abandoned and if so should be done so properly. Discarded pipe on WS slope should be removed. FIELD_STRUCT_DESC: 10-inch steel irrigation discharge pipe through the levee, 2.5 feet below the crown. Pump and gate valve in a pump house on the waterside (WS) slope. 4-foot by 4-foot concrete distribution box, power pole, and meter at the landside (LS) toe. [Additional Reference(s): DWR Levee Log, 2005. USACE Sacramento O&M Manual 105, April 1959, (HLM 2.5)]. FS Date: 4/21/2015

Pipe, conduit, and pipe debris on WS slope.

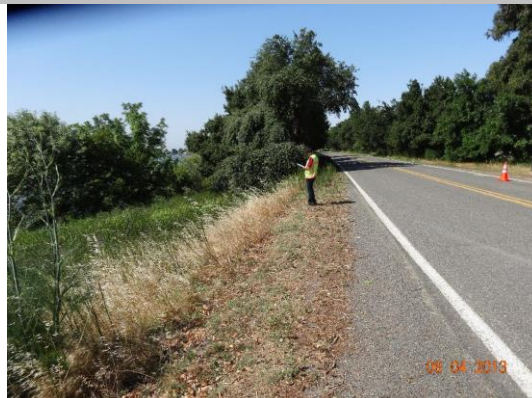
Photo 1 of 3 : UCIP\_FA\_2018\_32526\_58933.jpg

UCIP Comments: Dense vegetation limits the inspector's visibility to identify signs of pipe failure (leaks) through the levee slopes.

Overview of crown at crossing, looking downstream.

Recommend removing vegetation along pipe alignment to conduct proper inspection of structure and appurtenances. Additional notes: pump was running during inspection, 16-inch pipe debris section located on landward side, view of standpipe and support structure on waterward side does not match structure description--need to determine if crossing has been altered.

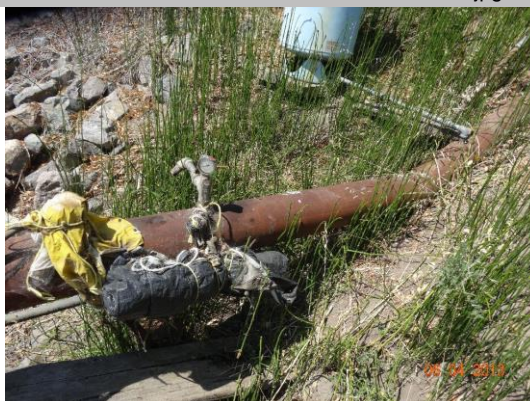
Photo 3 of 3 : UCIP\_FA\_2018\_53351\_58945.jpg

View of waterward side--pressure gauge, conduit, and wraps to prevent leaks.

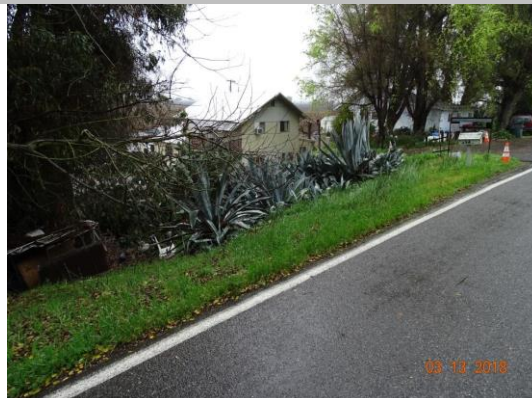
Photo 1 of 1 : FA\_2018\_RD0501\_169\_15\_20180925\_00001.jpg

LM Start	3.19	Rating **	U	Issue No.	15
LM End	3.22	Issue Type +	En	Location *	LS
Category	Earthen Levee			GPS Latitude/Longitude	
				Start	End
Item	Vegetation			38.210429 °	38.209974 °
				-121.610503 °	-121.610703 °
DWR ID	DWR_RD0501_01_s_2012_15				
Comment Code					
V6 : Landscaping					
Inspector Comment					
Large cactus and other landscaping should be thined or removed to allow inspection and access to landside slope and toe.

Cactus should be removed to allow inspection and access to levee slope.

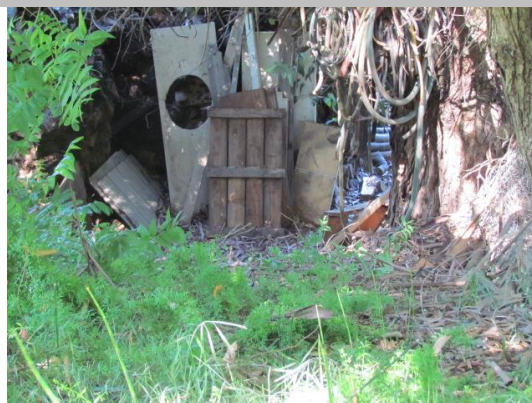
Photo 1 of 2 : FA\_2018\_RD0501\_169\_63\_20180925\_00011.jpg

LM Start	3.24	Rating **	U	Issue No.	63
LM End	3.24	Issue Type +	En	Location *	LS
Category	Earthen Levee			GPS Latitude/Longitude	
				Start	End
Item	Encroachments			38.209811 °	38.209713 °
				-121.610813 °	-121.610882 °
DWR ID	DWR_RD0501_01_f_2012_63				
Comment Code					
MA : Material					
Inspector Comment					
There is a large stock pile of fire wood, metal scrap, and other unwanted materials placed withinn the 10-foot easement landside that ned to be removed.

RD 501 Levee mile 3.24 landside toe.

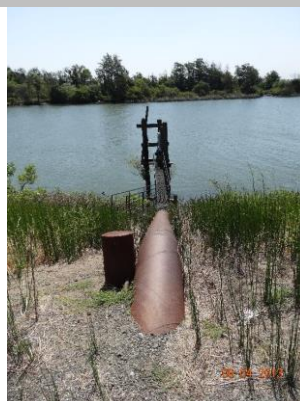
Photo 2 of 3 : UCIP\_FA\_2018\_32529\_58951.jpg

Comment Code						
Inspector Comment						
FS_ID:32529 DS_ID:21028 EP_NO: N/A Repair Type: Non-Urgent Crossing Status: Found UCIP Comments: Pipe was running during inspection. Crack on crown surface could be associated with pipe vibration during operation. Need to determine owner of crossing. Owner will need to clear vegetation along pipe alignment on landward side to prevent levee inspection along crossing. FIELD_STRUCT_DESC: 20-inch irrigation discharge pipe of an unknown material through the levee, 2.2 feet below the crown. 1.5-inch electrical conduit alongside the 20-inch pipe. Pump on a platform on the waterside (WS). Walkway present on the WS. Standpipe on the landside (LS) toe. Pipe exposed along both slopes. [Additional Reference(s): DWR Levee Log, 2005. USACE Sacramento O&M Manual 105, April 1959, (HLM 3.7)]. FS Date: 6/4/2013

View of waterward side--siphon breaker, walkway, platform, pump, and control panel.

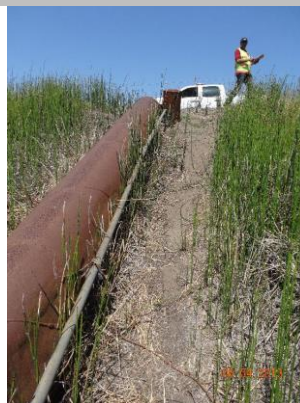
Photo 3 of 3 : UCIP\_FA\_2018\_32529\_58952.jpg

20-inch steel pipe along with 1.5-inch electrical conduit on landward side.

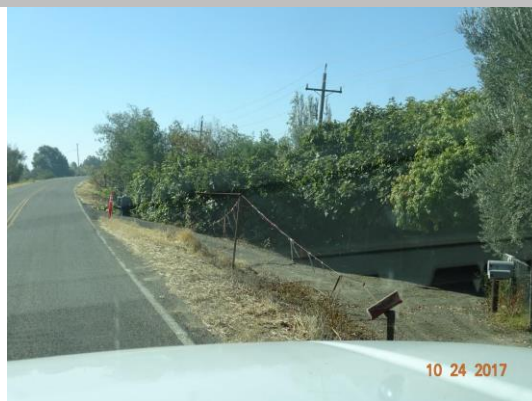
Photo 1 of 1 : FA\_2018\_RD0501\_169\_30\_20180925\_00005.jpg

LM Start	3.74	Rating **	M	Issue No.	30
LM End	3.74	Issue Type +	En	Location *	LS
Category	Earthen Levee			GPS Latitude/Longitude	
				Start	End
Item	Vegetation			38.202863 °	38.202863 °
				-121.613508 °	-121.613508 °
DWR ID	DWR_RD0501_01_f_2017_30				
Comment Code					
V6 : Landscaping					
Inspector Comment					
Landscaping should be thinned to allow inspection and access to slope and toe. Downed deadwood should also be removed from slope.

Landscaping should be thinned to allow inspection and access to slope and toe. Downed deadwood should also be removed from slope.

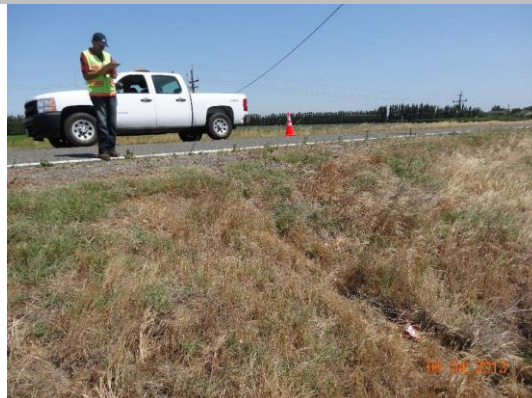
Photo 1 of 3 : UCIP\_FA\_2018\_19644\_33328.jpg

Comment Code					
Inspector Comment					
FS_ID:19644 DS_ID:21016 EP_NO: N/A Repair Type: Non-Urgent Crossing Status: Found UCIP Comments: Pipe section was altered/modified through levee crown. 12-inch pipe sleeved through existing pipe. Dense vegetation limits the inspector's visibility to identify signs of pipe failure (leaks) through the slope. Additional Notes: electrical conduit is disconnected on landside. Recommend removing vegetation along pipe alignment to conduct proper inspection of structure and appurtenances. Also need to contact owner to obtain maintenance records for crossing--need permit authorizing modifications. FIELD_STRUCT_DESC: 14-inch irrigation discharge pipe of an unknown material through the levee, 3.2 feet below the crown. 12-inch pipe sleeved through the existing 14-inch pipe with annular space grouted. 1.5-inch electrical conduit runs parallel along the 14-inch pipe. Pump on a pile structure in the channel. Walkway to the pump. [Additional Reference(s): DWR Levee Log, 2005. USACE Sacramento O&M Manual 105, April 1959, (HLM 4.6), 14-inch pipe listed]. FS Date: 6/4/2013

View of waterward side.

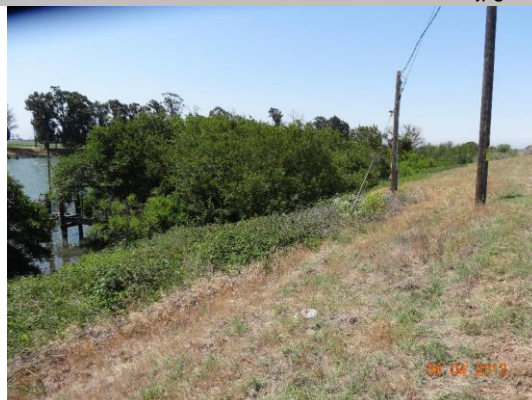
Photo 2 of 3 : UCIP\_FA\_2018\_19644\_33331.jpg

Overview of waterward side--pump station, platform, & power pole.

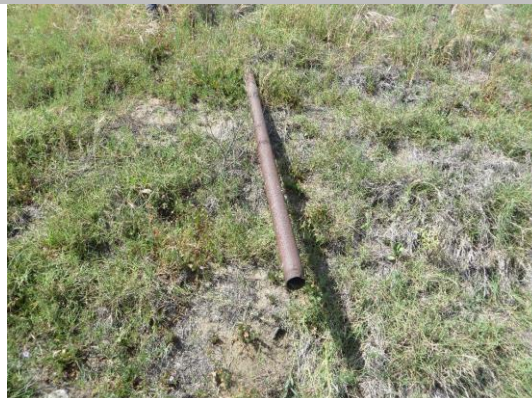
Photo 1 of 3 : UCIP\_FA\_2018\_50024\_73901.jpg

Comment Code					
Inspector Comment					
FS_ID:50024 DS_ID:21017 EP_NO: N/A Repair Type: Non-Urgent Crossing Status: Found UCIP Comments: 8/22/2016 Unable to locate conduit due to dense vegetation. Electrical conduit crossing has been downgraded from Urgent to Non-Urgent no damage to levee was observed. Dense vegetation was observed on both WS and LS. Recommend removing vegetation along pipe alignment to conduct proper inspection of structure and appurtenances. If crossing is abandoned owner will need to coordinate with CVFPB to remove crossing. (DWR UCIP - omagana)4/21/2016 Pipe abandoned and open on WS slope. Should be removed or abandoned properly. (DWR UCIP - omagana) FIELD_STRUCT_DESC: *ABANDONED* 2.5-inch steel electrical conduit through the levee, 4 feet below the crown. No Location marker was found on the waterside (WS) slope. [Additional Reference(s): DWR Levee Log, 2005]. FS Date: 8/22/2016

2.5-inch conduit visible on WS slope.

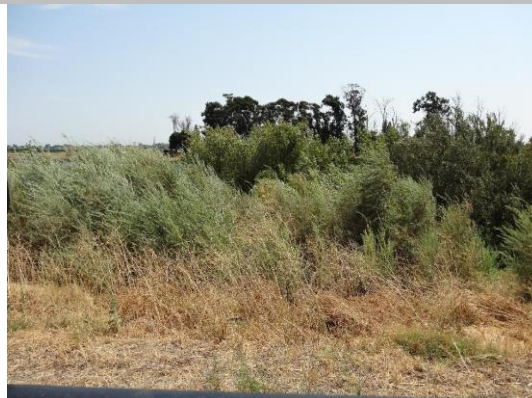
Photo 3 of 3 : UCIP\_FA\_2018\_50024\_75655.jpg

Comment Code						
Inspector Comment						
FS_ID:50024 DS_ID:21017 EP_NO: N/A Repair Type: Non-Urgent Crossing Status: Found UCIP Comments: 8/22/2016 Unable to locate conduit due to dense vegetation. Electrical conduit crossing has been downgraded from Urgent to Non-Urgent no damage to levee was observed. Dense vegetation was observed on both WS and LS. Recommend removing vegetation along pipe alignment to conduct proper inspection of structure and appurtenances. If crossing is abandoned owner will need to coordinate with CVFPB to remove crossing. (DWR UCIP - omagana)4/21/2016 Pipe abandoned and open on WS slope. Should be removed or abandoned properly. (DWR UCIP - omagana) FIELD_STRUCT_DESC: *ABANDONED* 2.5-inch steel electrical conduit through the levee, 4 feet below the crown. No Location marker was found on the waterside (WS) slope. [Additional Reference(s): DWR Levee Log, 2005]. FS Date: 8/22/2016

Dense vegetation on WS--unable to locate line.

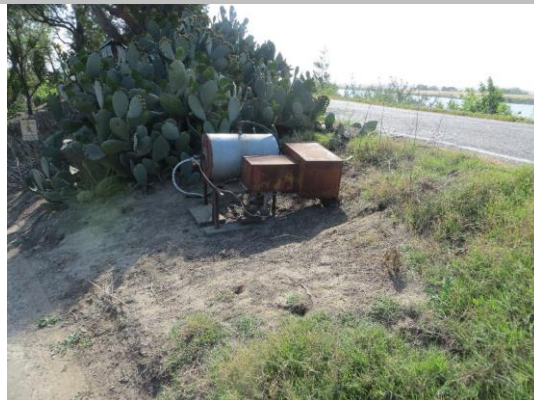
Photo 1 of 3 : UCIP\_FA\_2018\_44726\_73922.jpg

Comment Code						
Inspector Comment						
FS_ID:44726 DS_ID:21018 EP_NO: N/A Repair Type: Non-Urgent Crossing Status: Found UCIP Comments: Crossing appears abandoned as there are no connections at siphon pump on LS shoulder. If it is abandoned it should be done so properly. FIELD_STRUCT_DESC: 14-inch steel irrigation siphon pipe sleeved through a 16-inch steel pipe through the levee, 3 feet below the crown. Annular space grouted. Siphon pump/breaker on the landside (LS) shoulder. Steel standpipe with a slide gate at the LS toe. [Additional Reference(s): DWR Levee Log, 2005. USACE Sacramento O&M Manual 105, April 1959, (HLM 5.4), 16-inch pipe listed]. FS Date: 4/23/2015

Siphon pump on LS shoulder. No connection at this time.

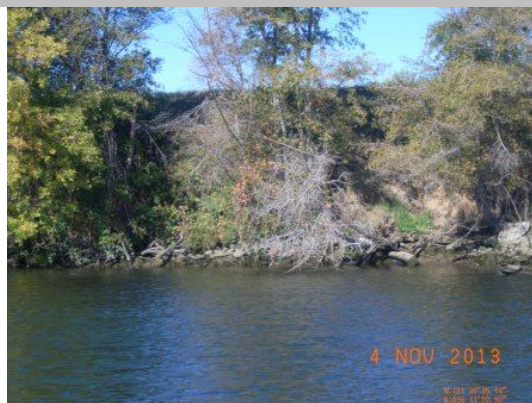
Photo 1 of 1 : FA\_2018\_RD0501\_169\_21\_20181106\_00069.jpg

LM Start	5.77	Rating **	M	Issue No.	21
LM End	5.84	Issue Type +	Ma	Location *	WS
Category	Supplemental			GPS Latitude/Longitude	
				Start	End
Item	2017 USACE Erosion Survey, DRAFT			38.190001°	38.189311°
				-121.643160°	-121.643917°
DWR ID	DWR_RD0501_01_f_2018_21				
Comment Code					
Inspector Comment					
2017 Site ID: STM 15.7 R					
Status: Eroding					
2017 Field Notes: No observed change.					
Site History: 2008 - Overstepped levee section with multiple small pockets of erosion 10 - 20 ft wide. 2013 - Site has fresh erosion and taller vertical sections.

USACE 2013 Photo #1

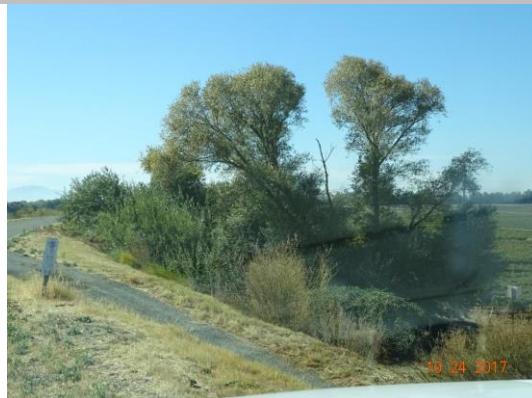
Photo 1 of 1 : FA\_2018\_RD0501\_169\_38\_20180925\_00008.jpg

LM Start	5.89	Rating **	U	Issue No.	38
LM End	5.89	Issue Type +	Ma	Location *	LS
Category	Earthen Levee			GPS Latitude/Longitude	
				Start	End
Item	Trim / Thin Trees			38.188870 °	38.188870 °
				-121.644732 °	-121.644732 °
DWR ID	DWR_RD0501_01_f_2017_38				
Comment Code					
T2 : Thin trees to allow visibility of the ground and room to flood fight.					
Inspector Comment					
Trim/thin/remove trees and undergrowth to allow inspection and access to slope and toe.

Trim/thin/remove trees and undergrowth to allow inspection and access to slope and toe.

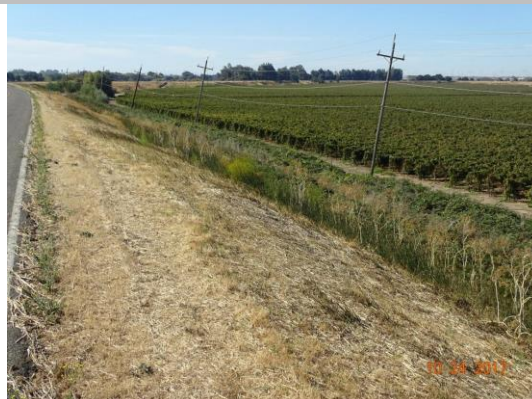
Photo 1 of 1 : FA\_2018\_RD0501\_169\_39\_20180925\_00009.jpg

LM Start	5.94	Rating **	M	Issue No.	39
LM End	6.15	Issue Type +	Ma	Location *	LS
Category	Earthen Levee			GPS Latitude/Longitude	
				Start	End
Item	Vegetation			38.188283 °	38.186090 °
				-121.645398 °	-121.648027 °
DWR ID	DWR_RD0501_01_f_2017_39				
Comment Code					
V2 : Remove the wild growth other than native grasses from the levee slopes.					
Inspector Comment					
Heavy blackberry growth along toe should be removed to allow inspection and access to toe. LMA reports ditch near toe inhibits ability to mow.

Heavy blackberry growth along toe, possibly over fence, should be removed to allow inspection and access to toe.

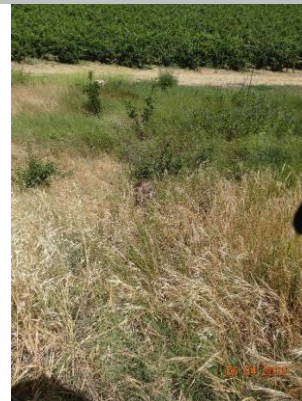
Photo 1 of 3 : UCIP\_FA\_2018\_32530\_58957.jpg

Comment Code						
Inspector Comment						
FS_ID:32530 DS_ID:21020 EP_NO: N/A Repair Type: Non-Urgent Crossing Status: Found UCIP Comments: Dense vegetation limits the inspector's visibility to identify signs of pipe failure (leaks) through the slope. Recommend removing vegetation along pipe alignment to conduct proper inspection of structure and appurtenances. If structure is no longer used--Need to contact owner to determine status. If crossing is no longer used owner will need to coordinate with CVFPB. FIELD_STRUCT_DESC: *ABANDONED* 16-inch irrigation discharge pipe of an unknown material through the levee, 6.5 feet below the crown. Siphon breaker and service pole on the landside (LS) shoulder. Electrical box at the LS toe. Pump on a pile structure in the channel. 3-inch steel sewer pipe sleeved through 16-inch pipe. Annular space grouted. ([Additional Reference(s): DWR Levee Log, 2005]. FS Date: 6/4/2013

Abandoned 16-inch pipe on landward side.

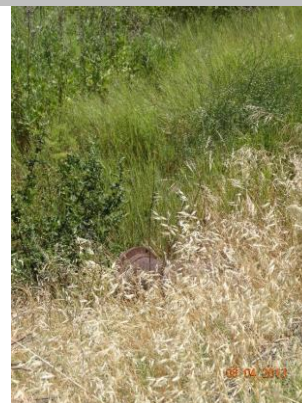
Photo 2 of 3 : UCIP\_FA\_2018\_32530\_58956.jpg

Overview of waterward side--section of pipe visible through dense vegetation.

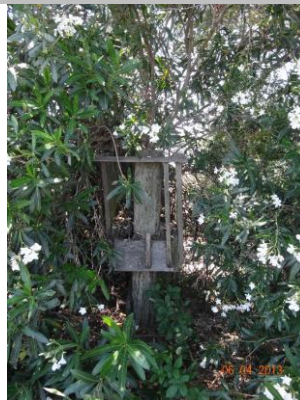
Photo 3 of 3 : UCIP\_FA\_2018\_32530\_58955.jpg

Comment Code						
Inspector Comment						
FS_ID:32530 DS_ID:21020 EP_NO: N/A Repair Type: Non-Urgent Crossing Status: Found UCIP Comments: Dense vegetation limits the inspector's visibility to identify signs of pipe failure (leaks) through the slope. Recommend removing vegetation along pipe alignment to conduct proper inspection of structure and appurtenances. If structure is no longer used--Need to contact owner to determine status. If crossing is no longer used owner will need to coordinate with CVFPB. FIELD_STRUCT_DESC: *ABANDONED* 16-inch irrigation discharge pipe of an unknown material through the levee, 6.5 feet below the crown. Siphon breaker and service pole on the landside (LS) shoulder. Electrical box at the LS toe. Pump on a pile structure in the channel. 3-inch steel sewer pipe sleeved through 16-inch pipe. Annular space grouted. ([Additional Reference(s): DWR Levee Log, 2005]. FS Date: 6/4/2013

Electrical box visible on landward toe.

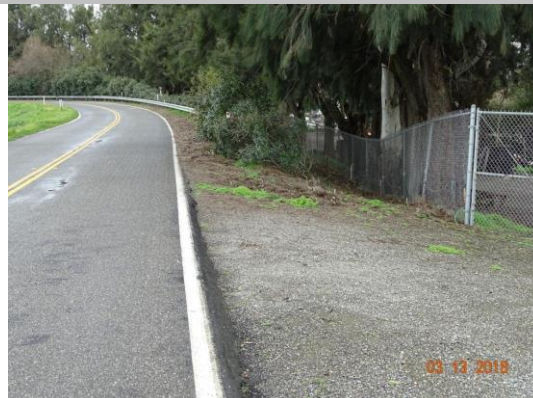
Photo 1 of 1 : FA\_2018\_RD0501\_170\_2\_20180925\_00001.jpg

LM Start	0.00	Rating **	M	Issue No.	2
LM End	0.09	Issue Type +	En	Location *	WS
Category	Earthen Levee			GPS Latitude/Longitude	
				Start	End
Item	Encroachments			38.184050 °	38.185178 °
				-121.657713 °	-121.658515 °
DWR ID	DWR_RD0501_02_s_2012_2				
Comment Code					
FE : Fence					
Inspector Comment					
This is the chainlink fence behind the guardrail.

Chainlink fence behind guardrail is not permitted.

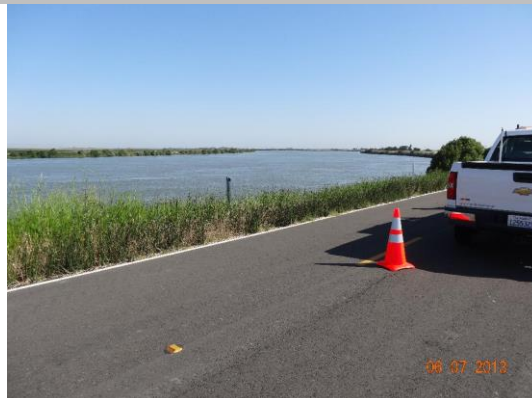
Photo 1 of 3 : UCIP\_FA\_2018\_32531\_58960.jpg

Comment Code						
Inspector Comment						
FS_ID:32531 DS_ID:21035 EP_NO: N/A Repair Type: Non-Urgent Crossing Status: Found UCIP Comments: Dense vegetation limits the inspector's visibility to identify signs of pipe failure (leaks) through the slope. Recommend removing vegetation along pipe alignment to conduct proper inspection of structure and appurtenances. Need to determine owner and status of crossing. FIELD_STRUCT_DESC: 10-inch irrigation discharge pipe of an unknown material sleeved through a 12-inch pipe of an unknown material through the levee, 5 feet below the crown. Pump on the waterside (WS). [Additional Reference(s): DWR Levee Log, 2005. USACE Sacramento O&M Manual 105, April 1959, (HLM 0.6)]. FS Date: 6/7/2013

View of crown.

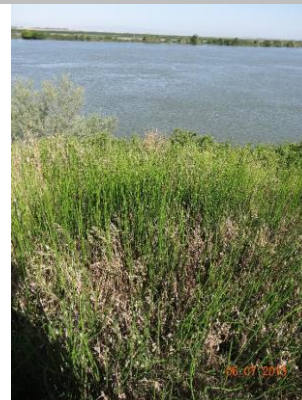
Photo 2 of 3 : UCIP\_FA\_2018\_32531\_58958.jpg

Overview of waterward side. Inaccessible due to dense vegetation.

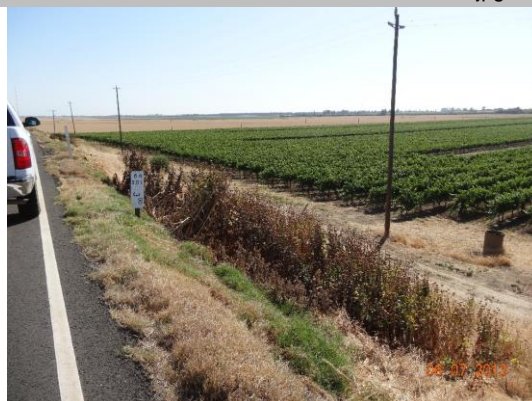
Photo 3 of 3 : UCIP\_FA\_2018\_32531\_58959.jpg

Comment Code						
Inspector Comment						
FS_ID:32531 DS_ID:21035 EP_NO: N/A Repair Type: Non-Urgent Crossing Status: Found UCIP Comments: Dense vegetation limits the inspector's visibility to identify signs of pipe failure (leaks) through the slope. Recommend removing vegetation along pipe alignment to conduct proper inspection of structure and appurtenances. Need to determine owner and status of crossing. FIELD_STRUCT_DESC: 10-inch irrigation discharge pipe of an unknown material sleeved through a 12-inch pipe of an unknown material through the levee, 5 feet below the crown. Pump on the waterside (WS). [Additional Reference(s): DWR Levee Log, 2005. USACE Sacramento O&M Manual 105, April 1959, (HLM 0.6)]. FS Date: 6/7/2013

Overview of landward side.

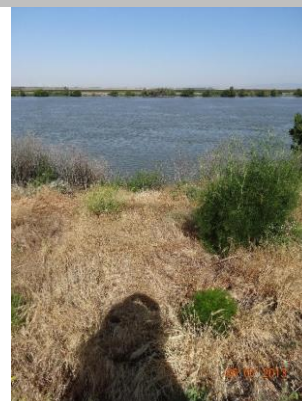
Photo 1 of 3 : UCIP\_FA\_2018\_53353\_58967.jpg

Comment Code					
Inspector Comment					
FS_ID:53353 DS_ID:21092 EP_NO: 3703 Repair Type: Urgent Crossing Status: Found UCIP Comments: 07/24/2018 Same as last inspection. Could not inspect WS due to overgrown vegetation. Keeping Urgent due to pipe integrity concerns and threat to levee integrity (D. Sanoski - DWR UCIP).8/22/2016 Same as last inspection -- pipe is deteriorating and breaking apart (visible on WS). (DWR UCIP - omagana)6/07/2013 Deteriorated pipe with holes present at intake. Dense vegetation limits the inspector's visibility to identify signs of pipe failure (leaks) through the slope. Recommend removing vegetation along pipe alignment to conduct proper inspection of structure and appurtenances. If crossing is no longer used --owner will need coordinate with CVFPB to address crossing. Need to coordinate with DWR Inspector and CVFPB. (DWR UCIP - omagana) FIELD_STRUCT_DESC: *ABANDONED* 8-inch steel irrigation siphon pipe through the levee, 1.7 feet below the crown. Siphon breaker on the apex of the pipe on the landside (LS) shoulder. Pipe discharges into a concrete sump near the LS toe. Pipe is exposed along the LS slope. Second 8-inch pipe approximately 1 foot apart is visible on the LS. Pipe is also visible on the waterside (WS). (Retention of an existing 8-inch siphon pipe through the levee authorized under Permit No. 3703, 1961 - Enzo Guidi). [Additional Reference(s): DWR Levee Log, 2005]. FS Date: 7/24/2018 3:43:00 PM

Overview of WS--20 foot berm present.

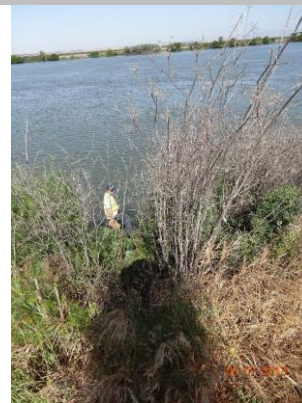
Photo 2 of 3 : UCIP\_FA\_2018\_53353\_58965.jpg

View of WS. Inspector is standing near exposed section of pipe at levee toe.

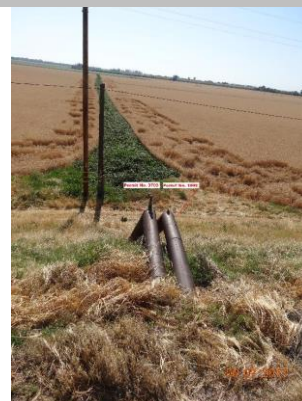
Photo 1 of 3 : UCIP\_FA\_2018\_53354\_58968.jpg

Comment Code					
Inspector Comment					
FS_ID:53354 DS_ID:21036 EP_NO: 1902 Repair Type: Urgent Crossing Status: Found UCIP Comments: 07/24/2018 Same as last inspection. Could not inspect WS due to overgrown vegetation. Keeping Urgent due to pipe integrity concerns and threat to levee integrity (D. Sanoski - DWR UCIP).8/22/2016 Same as previous inspection. Pipe is deteriorating and open on WS. (DWR UCIP - omagana)6/07/2013 Reason for an Urgent Priority is due to adjacent crossing--adjacent crossing has holes present and is was installed in the 1960s. Our records show this pipe was installed before 1955. Dense vegetation limits the inspector's visibility to identify signs of pipe failure (leaks) through the slope. Recommend removing vegetation along pipe alignment to conduct proper inspection of structure and appurtenances. If crossing is no longer in use--Owner will need to coordinate with DWR Inspector and CVFPB. Need to determine condition of pipe--request maintenance records from owner once found--this crossing could be capped and grouted--NEED RECORDS. (DWR UCIP - omagana) FIELD_STRUCT_DESC: *ABANDONED* 8-inch steel irrigation siphon pipe encased in a 10-inch, 14 gage corrugated metal pipe (CMP) through the levee, 1.7 feet below the crown. Siphon breaker on the apex of the pipe on the landside (LS) shoulder. Pipe discharges into a concrete sump near the LS toe. Pipe exposed along the LS slope. (Plans for replacing an existing pipe through the levee authorized under Permit No. 1902, 1954 - Enzo Guidi). [Additional Reference(s): DWR Levee Log, 2005. USACE Sacramento O&M Manual 105, April 1959, (HLM 0.9)]. FS Date: 7/24/2018 3:36:00 PM

8-inch pipes approximately 1 foot apart.

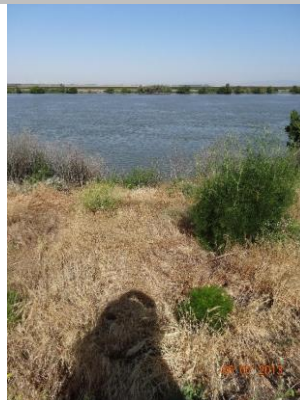
Photo 2 of 3 : UCIP\_FA\_2018\_53354\_58970.jpg

Comment Code						
Inspector Comment						
FS_ID:53354 DS_ID:21036 EP_NO: 1902 Repair Type: Urgent Crossing Status: Found UCIP Comments: 07/24/2018 Same as last inspection. Could not inspect WS due to overgrown vegetation. Keeping Urgent due to pipe integrity concerns and threat to levee integrity (D. Sanoski - DWR UCIP).8/22/2016 Same as previous inspection. Pipe is deteriorating and open on WS. (DWR UCIP - omagana)6/07/2013 Reason for an Urgent Priority is due to adjacent crossing--adjacent crossing has holes present and is was installed in the 1960s. Our records show this pipe was installed before 1955. Dense vegetation limits the inspector's visibility to identify signs of pipe failure (leaks) through the slope. Recommend removing vegetation along pipe alignment to conduct proper inspection of structure and appurtenances. If crossing is no longer in use--Owner will need to coordinate with DWR Inspector and CVFPB. Need to determine condition of pipe--request maintenance records from owner once found--this crossing could be capped and grouted--NEED RECORDS. (DWR UCIP - omagana) FIELD_STRUCT_DESC: *ABANDONED* 8-inch steel irrigation siphon pipe encased in a 10-inch, 14 gage corrugated metal pipe (CMP) through the levee, 1.7 feet below the crown. Siphon breaker on the apex of the pipe on the landside (LS) shoulder. Pipe discharges into a concrete sump near the LS toe. Pipe exposed along the LS slope. (Plans for replacing an existing pipe through the levee authorized under Permit No. 1902, 1954 - Enzo Guidi). [Additional Reference(s): DWR Levee Log, 2005. USACE Sacramento O&M Manual 105, April 1959, (HLM 0.9)]. FS Date: 7/24/2018 3:36:00 PM

Overview of waterward side--20 foot berm present.

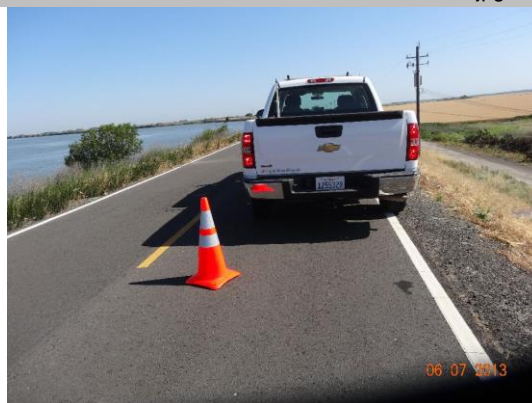
Photo 1 of 3 : UCIP\_FA\_2018\_44865\_58975.jpg

Comment Code						
Inspector Comment						
FS_ID:44865 DS_ID:21038 EP_NO: 2817 Repair Type: Non-Urgent Crossing Status: Found UCIP Comments: Dense vegetation limits the inspector's visibility to identify signs of pipe failure (leaks) through the slope. Recommend removing vegetation along pipe alignment to conduct proper inspection of structure and appurtenances. Scour hole located on waterward side. FIELD_STRUCT_DESC: 20-inch steel drainage discharge pipe sleeved through a 24-inch steel pipe through the levee, 9 feet below the crown. Flap gate on the waterside (WS) end. Cutoff wall around the pipe at each shoulder. Pipe exposed along both slopes. Rock revetment on the WS slope. Berm on the WS is over 20 feet. (Plans to install a drainage pipe through the levee authorized under Permit No. 2817, 1958 - Reclamation District No. 501 [RD0501]). [Additional Reference(s): DWR Levee Log, 2005]. FS Date: 6/7/2013

View of levee crown at crossings.

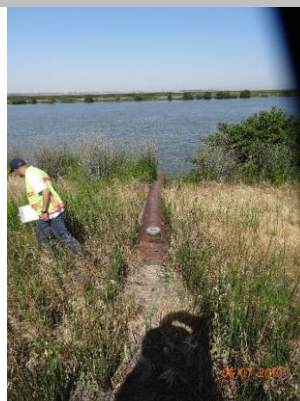
Photo 2 of 3 : UCIP\_FA\_2018\_44865\_58972.jpg

Comment Code						
Inspector Comment						
FS_ID:44865 DS_ID:21038 EP_NO: 2817 Repair Type: Non-Urgent Crossing Status: Found UCIP Comments: Dense vegetation limits the inspector's visibility to identify signs of pipe failure (leaks) through the slope. Recommend removing vegetation along pipe alignment to conduct proper inspection of structure and appurtenances. Scour hole located on waterward side. FIELD_STRUCT_DESC: 20-inch steel drainage discharge pipe sleeved through a 24-inch steel pipe through the levee, 9 feet below the crown. Flap gate on the waterside (WS) end. Cutoff wall around the pipe at each shoulder. Pipe exposed along both slopes. Rock revetment on the WS slope. Berm on the WS is over 20 feet. (Plans to install a drainage pipe through the levee authorized under Permit No. 2817, 1958 - Reclamation District No. 501 [RD0501]). [Additional Reference(s): DWR Levee Log, 2005]. FS Date: 6/7/2013

View of waterward side--pipe section exposed and siphon breaker. Over 20 feet berm on waterward side.

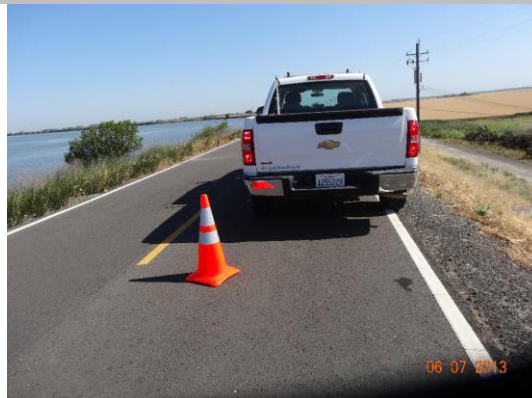
Photo 1 of 3 : UCIP\_FA\_2018\_44866\_58981.jpg

Comment Code						
Inspector Comment						
FS_ID:44866						
DS_ID:21094						
EP_NO: 14491						
Repair Type: Non-Urgent						
Crossing Status: Found						
UCIP Comments: Dense vegetation limits the inspector's visibility to identify signs of pipe failure (leaks) through the slope. Recommend removing vegetation along pipe alignment to conduct proper inspection of structure and appurtenances. Scour hole present on waterward side. FIELD_STRUCT_DESC: 24-inch coated steel drainage discharge pipe through the levee, 4.5 feet below the crown. Cutoff wall around the pipe at the center of the levee. Siphon breaker on the apex of the pipe at the waterside (WS) shoulder. Pump on the landside (LS). (Plans to install a 24-inch water discharge pipe through the levee authorized under Permit No. 14491, 1986 - Reclamation District No. 501 [RD0501]).						
FS Date: 6/7/2013

View of downstream crown.

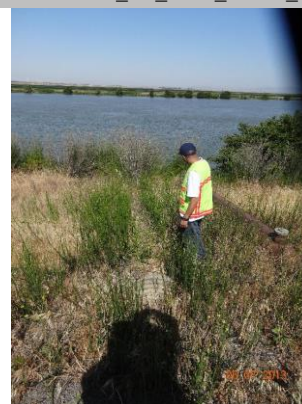
Photo 2 of 3 : UCIP\_FA\_2018\_44866\_58979.jpg

Two pipes on waterside.

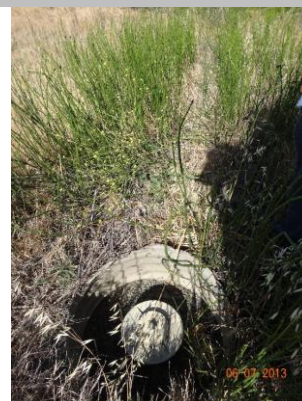
Photo 3 of 3 : UCIP\_FA\_2018\_44866\_58976.jpg

Comment Code						
Inspector Comment						
FS_ID:44866 DS_ID:21094 EP_NO: 14491 Repair Type: Non-Urgent Crossing Status: Found UCIP Comments: Dense vegetation limits the inspector's visibility to identify signs of pipe failure (leaks) through the slope. Recommend removing vegetation along pipe alignment to conduct proper inspection of structure and appurtenances. Scour hole present on waterward side. FIELD_STRUCT_DESC: 24-inch coated steel drainage discharge pipe through the levee, 4.5 feet below the crown. Cutoff wall around the pipe at the center of the levee. Siphon breaker on the apex of the pipe at the waterside (WS) shoulder. Pump on the landside (LS). (Plans to install a 24-inch water discharge pipe through the levee authorized under Permit No. 14491, 1986 - Reclamation District No. 501 [RD0501]). FS Date: 6/7/2013

Siphon breaker located at the waterward shoulder.

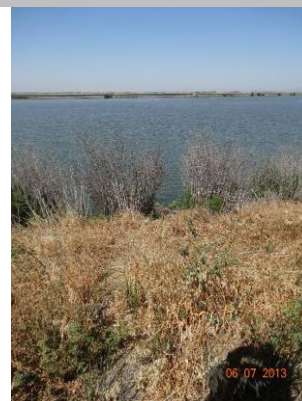
Photo 1 of 3 : UCIP\_FA\_2018\_44867\_58987.jpg

Comment Code						
Inspector Comment						
FS_ID:44867 DS_ID:21093 EP_NO: 13520 Repair Type: Non-Urgent Crossing Status: Found UCIP Comments: Dense vegetation limits the inspector's visibility to identify signs of pipe failure (leaks) through the slope. Recommend removing vegetation along pipe alignment to conduct proper inspection of structure and appurtenances. Owner needs to be informed about the vegetation clearance required for proper inspection. FIELD_STRUCT_DESC: 18-inch coated steel irrigation siphon pipe through the levee, 3.4 feet below the crown. Steel cutoff wall around the pipe at the center of the levee. Siphon breaker on the apex of the pipe on the landside (LS) shoulder. Pipe extends from a sump off the LS toe. Pipe exposed along the waterside (WS) slope. Rock revetment on the WS slope. (Plans to remove two siphons and install one 18-inch steel siphon through the levee authorized under Permit No. 13520, 1982 - Lewis Nixon Company). FS Date: 6/7/2013

Overview of waterside. Dense vegetation.

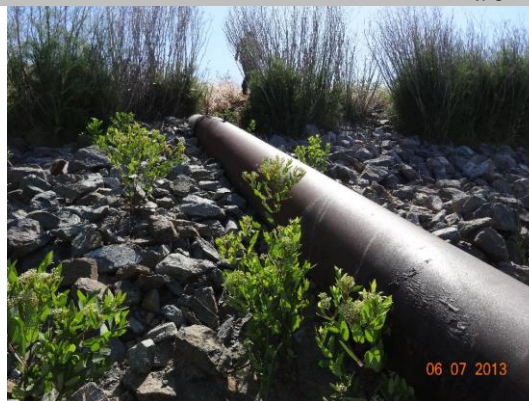
Photo 2 of 3 : UCIP\_FA\_2018\_44867\_58982.jpg

View of waterward side--pipe extends from berm to river.

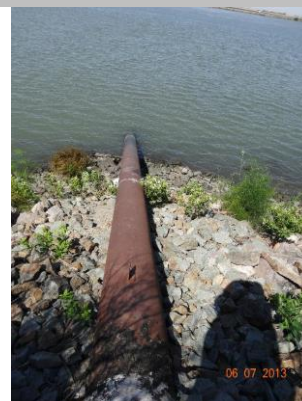
Photo 3 of 3 : UCIP\_FA\_2018\_44867\_58985.jpg

Comment Code						
Inspector Comment						
FS_ID:44867 DS_ID:21093 EP_NO: 13520 Repair Type: Non-Urgent Crossing Status: Found UCIP Comments: Dense vegetation limits the inspector's visibility to identify signs of pipe failure (leaks) through the slope. Recommend removing vegetation along pipe alignment to conduct proper inspection of structure and appurtenances. Owner needs to be informed about the vegetation clearance required for proper inspection. FIELD_STRUCT_DESC: 18-inch coated steel irrigation siphon pipe through the levee, 3.4 feet below the crown. Steel cutoff wall around the pipe at the center of the levee. Siphon breaker on the apex of the pipe on the landside (LS) shoulder. Pipe extends from a sump off the LS toe. Pipe exposed along the waterside (WS) slope. Rock revetment on the WS slope. (Plans to remove two siphons and install one 18-inch steel siphon through the levee authorized under Permit No. 13520, 1982 - Lewis Nixon Company). FS Date: 6/7/2013

Photo of pipe looking from berm edge to river edge.

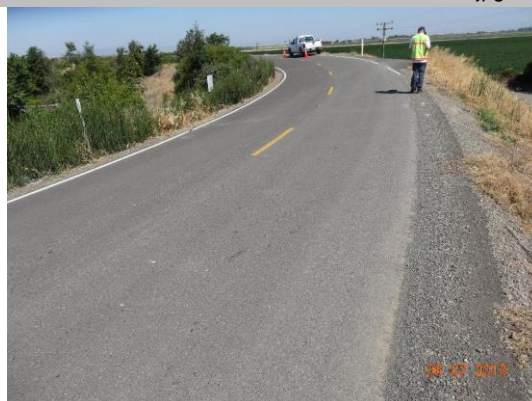
Photo 1 of 3 : UCIP\_FA\_2018\_40489\_33358.jpg

Comment Code					
Inspector Comment					
FS_ID:40489 DS_ID:21042 EP_NO: 15477 Repair Type: Non-Urgent Crossing Status: Found UCIP Comments: Stacey Boyd, LMA superintendent for RD0501, confirmed the removal and replacement of existing crossing under new permit no. 18811. New crossing will be a 30-inch diameter discharge pipe above the design flood plane. Construction will start soon. Update record once the project is completed. Dense vegetation on both waterside and landside. Recommend removing vegetation along pipe alignment to conduct proper inspection of structure and appurtenances. FIELD_STRUCT_DESC: 42-inch steel drainage discharge pipe through the levee, 6.5 feet below the crown. Siphon breaker on the waterside (WS) slope. Pump on the landside (LS). Pipe exposed along both slopes. (Plans to replace two pipes with two 36-inch discharge pipes through the levee authorized under Permit No. 15477, 1990 - Reclamation District No. 501 [RD0501]). Permit does not match this crossing. Recommend deletion of permit. [Additional Reference(s): DWR Levee Log, 2005. USACE Sacramento O&M Manual 105, April 1959, (HLM 2.0)]. FS Date: 6/7/2013

Overview of crown, looking downstream.

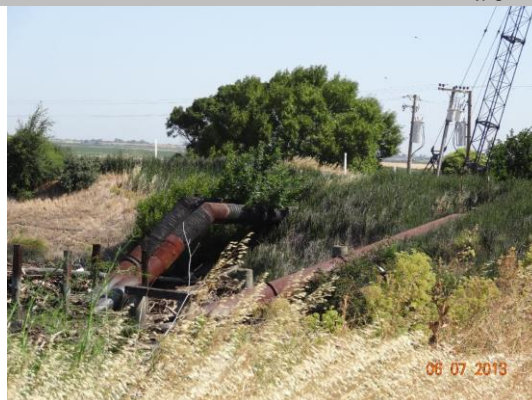
Photo 2 of 3 : UCIP\_FA\_2018\_40489\_33359.jpg

One 42-inch steel pile with siphon break on waterside slope.

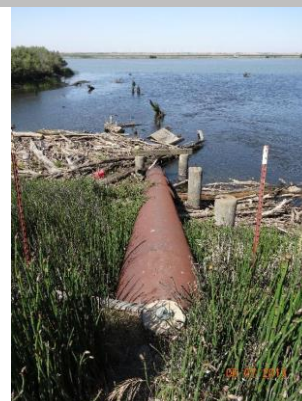
Photo 3 of 3 : UCIP\_FA\_2018\_40489\_33357.jpg

Comment Code						
Inspector Comment						
FS_ID:40489 DS_ID:21042 EP_NO: 15477 Repair Type: Non-Urgent Crossing Status: Found UCIP Comments: Stacey Boyd, LMA superintendent for RD0501, confirmed the removal and replacement of existing crossing under new permit no. 18811. New crossing will be a 30-inch diameter discharge pipe above the design flood plane. Construction will start soon. Update record once the project is completed. Dense vegetation on both waterside and landside. Recommend removing vegetation along pipe alignment to conduct proper inspection of structure and appurtenances. FIELD_STRUCT_DESC: 42-inch steel drainage discharge pipe through the levee, 6.5 feet below the crown. Siphon breaker on the waterside (WS) slope. Pump on the landside (LS). Pipe exposed along both slopes. (Plans to replace two pipes with two 36-inch discharge pipes through the levee authorized under Permit No. 15477, 1990 - Reclamation District No. 501 [RD0501]). Permit does not match this crossing. Recommend deletion of permit. [Additional Reference(s): DWR Levee Log, 2005. USACE Sacramento O&M Manual 105, April 1959, (HLM 2.0)]. FS Date: 6/7/2013

Siphon breaker on apex of steel pipe waterside.

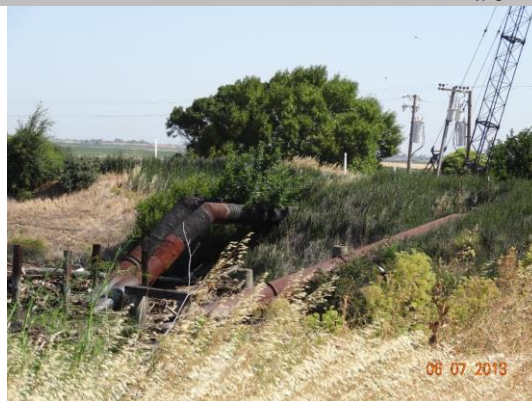
Photo 2 of 3 : UCIP\_FA\_2018\_47049\_33373.jpg

Comment Code						
Inspector Comment						
FS_ID:47049 DS_ID:21091 EP_NO: 15477 Repair Type: Non-Urgent Crossing Status: Found UCIP Comments: Dense vegetation limits the inspector's visibility to identify signs of pipe failure (leaks) through the slope. Recommend removing vegetation along pipe alignment to conduct proper inspection of structure and appurtenances. FIELD_STRUCT_DESC: 1 of 2: 36-inch coated steel drainage discharge pipe through the levee, 7 feet below the crown. Siphon breaker on the waterside (WS) shoulder. Pump on the landside (LS). Pipe exposed along both slopes. Pipe supports at levee shoulders were cutoff walls from a preexisting pipe. Pipes are approximately 36 inches apart. (Plans to replace two pipes with two 36-inch discharge pipes through the levee authorized under Permit No. 15477, 1990 - Reclamation District No. 501 [RD0501]). [Additional Reference(s): DWR Levee Log, 2005]. FS Date: 6/7/2013

Overview of dual pipes on waterward side.
